28 Die in Pioneer Hotel, Tucson, Arizona

LAURENCE D. WATROUS

Supervisor, NFPA Fire Record Department

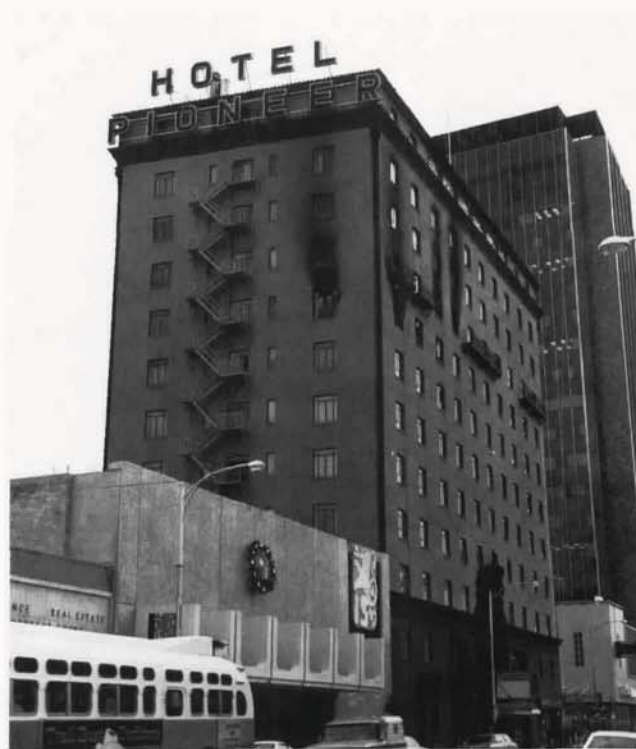
The main section, looking from the north. North Stone Avenue is in the foreground.

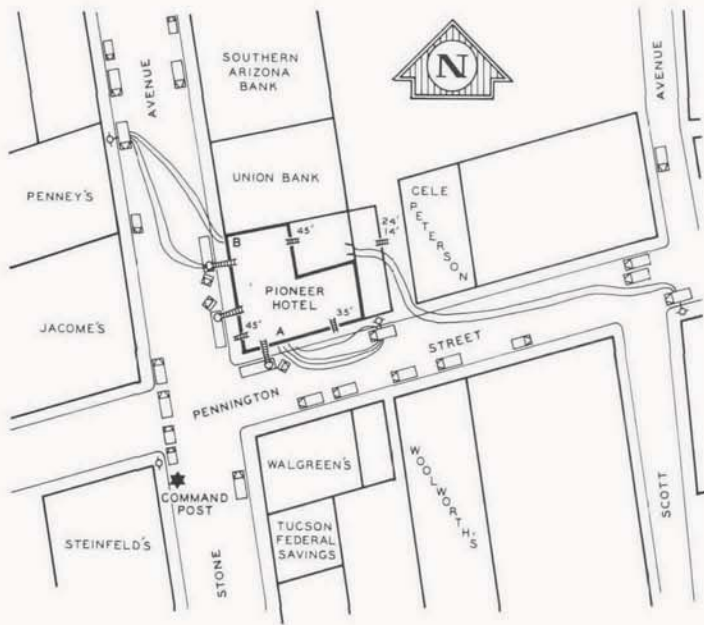
Figure 1. Fireground diagram of hotel area. A is location of dry standpipe siamense. B is location of wet standpipe siamense.
